HUTT VALLEY DISTRICT HEALTH BOARD

HERETAUNGA BUILDING, HUTT HOSPITAL

TECHNICAL REPORTS (as at 13 May 2022)

Reference: 520602 Revision: 0 2022-02-15

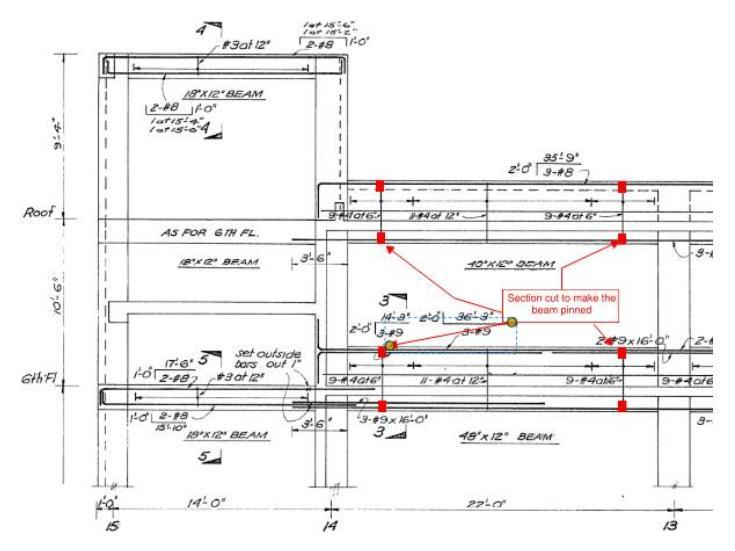
The performance of the Moment Resisting Frames is governed by weak story failure. This limited the level of available ductility considered in the assessment and resulted in larger seismic loads. Apart from the weak storey failure, it was found that the inter-storey drifts are at the limit of code requirements.

Given the beams had closely spaced shear reinforcement, it is believed that some ductility can be introduced into the structure if the weak storey failure mechanism is addressed. To do so as well as keep the drift within the code limitation, the flexural capacity of the beams is suggested to be reduced while the flexural capacity of the column is suggested to be improved. Weakening of the deep spandrel beams can be achieved by selectively cutting some longitudinal reinforcing bars to achieve the required ductility of the frames and remediate the weak story failure mechanism.

An illustration of possible weakening is shown in Figure 11.

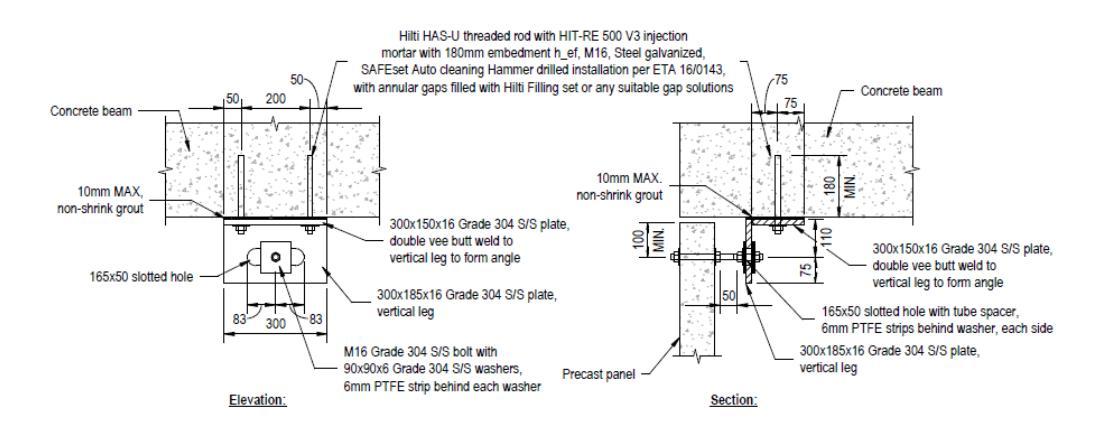
Connection Type 1: (Top Connection)

The capacity of the precast façade panel connections are not sufficient and require both strengthening and provision for seismic movement. Figure 12 and Figure 13 show an example of a typical precast panel connection upgrade. Upgraded connections would need to be provided to all the precast panels.

It would be worth exploring whether the existing precast panels could be removed entirely, and new cladding panels be installed. The design of the new panels and connections can incorporate lateral movement requirements. Adding new and lighter cladding system for the building would also assist in reducing the weight of the building.

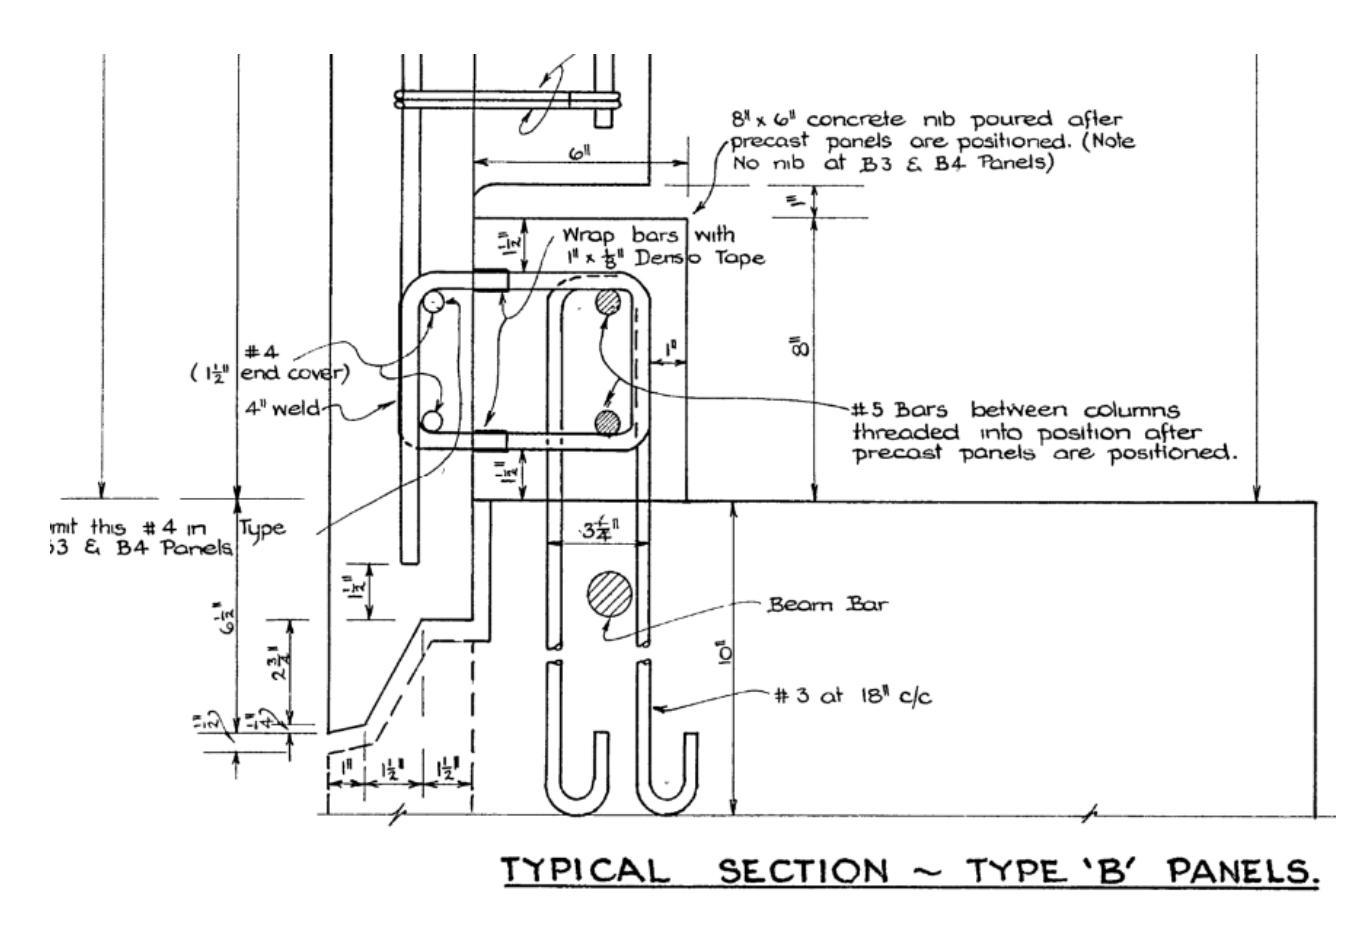
Figure 6: Typical Panel Connection

There are generally 2 options to consider for remediation of precast cladding panels.

The first option would be to provide new panel connections that allow for movement of the panels. This option would require access to the back of every panel in the building, installation of new brackets, and then cutting free of the existing panels. As the current connections are largely cast in there would be significant work required in cutting free the panels that we do not believe to be feasible. Refer to Figure 6.

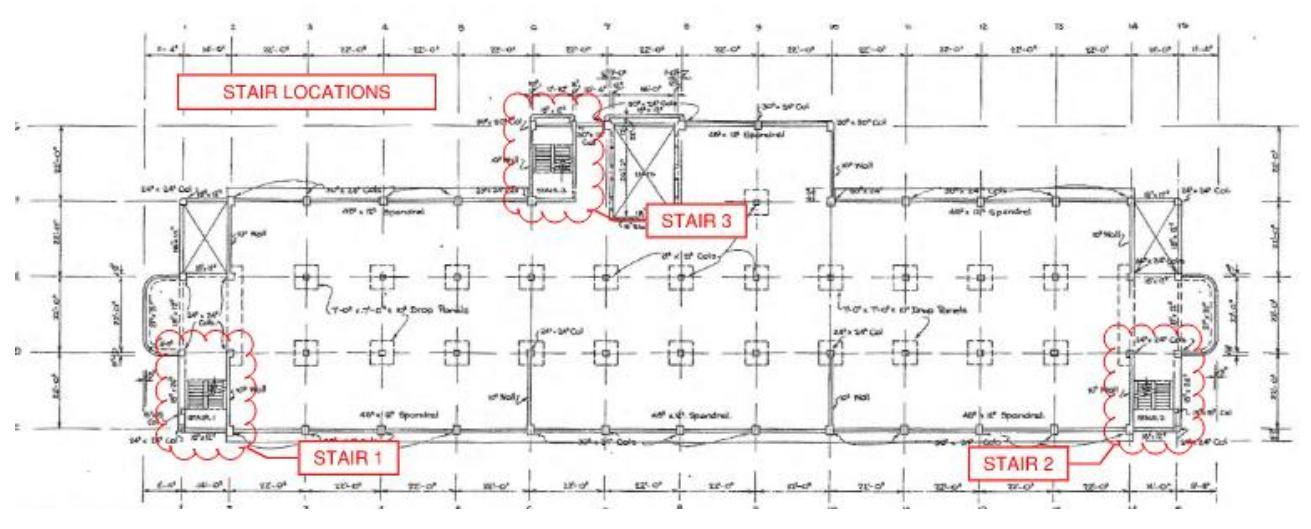
Figure 7: Stair locations

The precast stair beams are connected to the in-situ landings with cast-in reinforcing bars. The landings are also rigidly connected to the surrounding concrete walls and do not allow for lateral movement of the building. This means that they are likely to attract force under earthquake loading and fail in a potentially brittle manner.

To avoid this type of failure, allowance for movement must be provided. We would propose to do this by detaching the stairs from the primary structure at the mid-landings and providing a secondary gravity support system. This is described in Figure 7, Figure 8 and Figure 9.
