HUTT VALLEY DISTRICT HEALTH BOARD

HERETAUNGA BUILDING, HUTT HOSPITAL

TECHNICAL REPORTS (as at 13 May 2022)

Reference: 520602 Revision: 0 2022-02-15

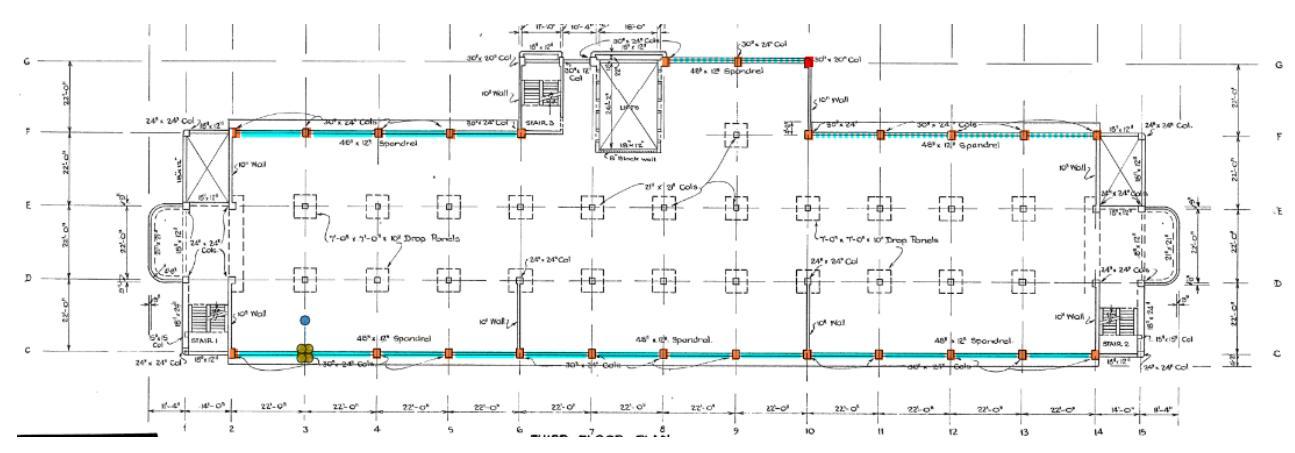
Figure 5: Moment Resisting Frames in the longitudinal direction

The Moment Resisting Frames comprise of concrete columns and deep spandrel beams. Columns were rectangular with dimensions between 610mm and 762 mm. Beam widths range between 305mm and 381 mm and their heights range between 1219 mm and 2286mm. As per assessment, these dimensions for beams and columns have contributed in all stories being vulnerable to weak storey failure.

Moment resisting frames in the longitudinal direction of the building are composed of concrete columns and deep reinforced beams. The relatively high capacity of the deep beams means that the frames are vulnerable to weak-story failure at most levels of the building. A weak storey failure means that there is high chance that all deformation is concentrated on one specific floor leading to that storey become pancaked between two adjacent floors. Because of this, a ductility of 1.25 (μ =1.25) was considered for the assessment of the building in the longitudinal direction. The beams and columns are scored a minimal value of 15%*NBS*(IL3), limited by their flexural capacity. The columns scored lowest at roof level and level 3, and the beams scored lowest at the third floor. A summary of the beam and column scores is provided in Table 8 for beams and in Table 9 for columns.

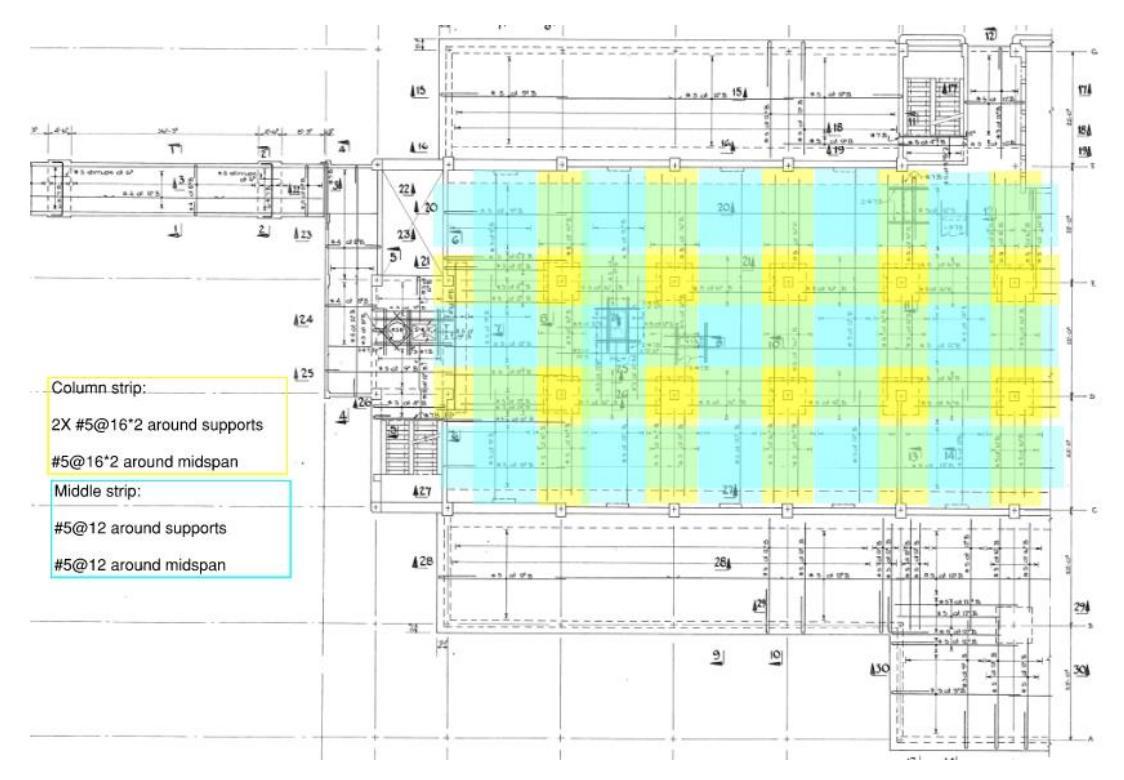
Figure 6: Diaphragm reinforcement (first floor - bottom reinforcement)

The diaphragm of the structure features concrete flat slab (cast in-situ without beams) with thickenings over the internal gravity columns (Column caps with thickness of 406 mm). The thickness of the slabs for levels 1 to roof is 160 mm and 254 mm for the plant floor and basement. The concrete slabs were reinforced with 16mm diameter deformed bars in each direction typically. Starter bars around the perimeter of the slab connected the slab to the concrete beams and walls. Figure 6 shows an example reinforcement of the diaphragm.

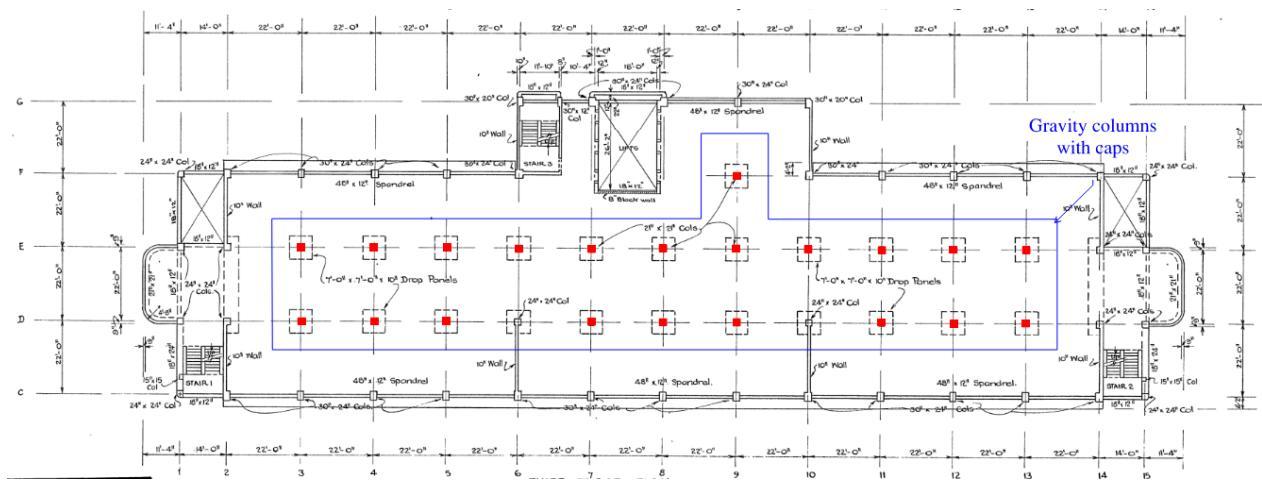
Figure 7: Internal gravity columns with caps (No internal beams – flat slab)

The internal columns, as shown in Figure 7, were part of the gravity system and do not participate in lateral load resistance. Column capitals (slab thickenings) are located around the internal columns.

The reinforced concrete gravity columns had thickenings where connecting to the slabs (column capitals). They were assessed for punching-shear failure and drift capacity at the onset of gravity resistance loss. Assessment of the gravity columns found they were not susceptible to punching shear but due to low drift capacity, they scored 45%NBS(IL3). The relatively large gravity load demands on the columns contributed to their low drift capacity.

The internal gravity columns (shown in Figure 7) have limited deflection capacity due to large axial gravity loads and inconsiderable amounts of transverse reinforcement. The gravity columns could be strengthened by increasing their shear capacity. This can be achieved by, for example, adding an external steel jacket or Fibre Reinforced Polymer (FRP) wrap around the column. Other options include reducing the gravity load on the columns or increasing their gross section area.

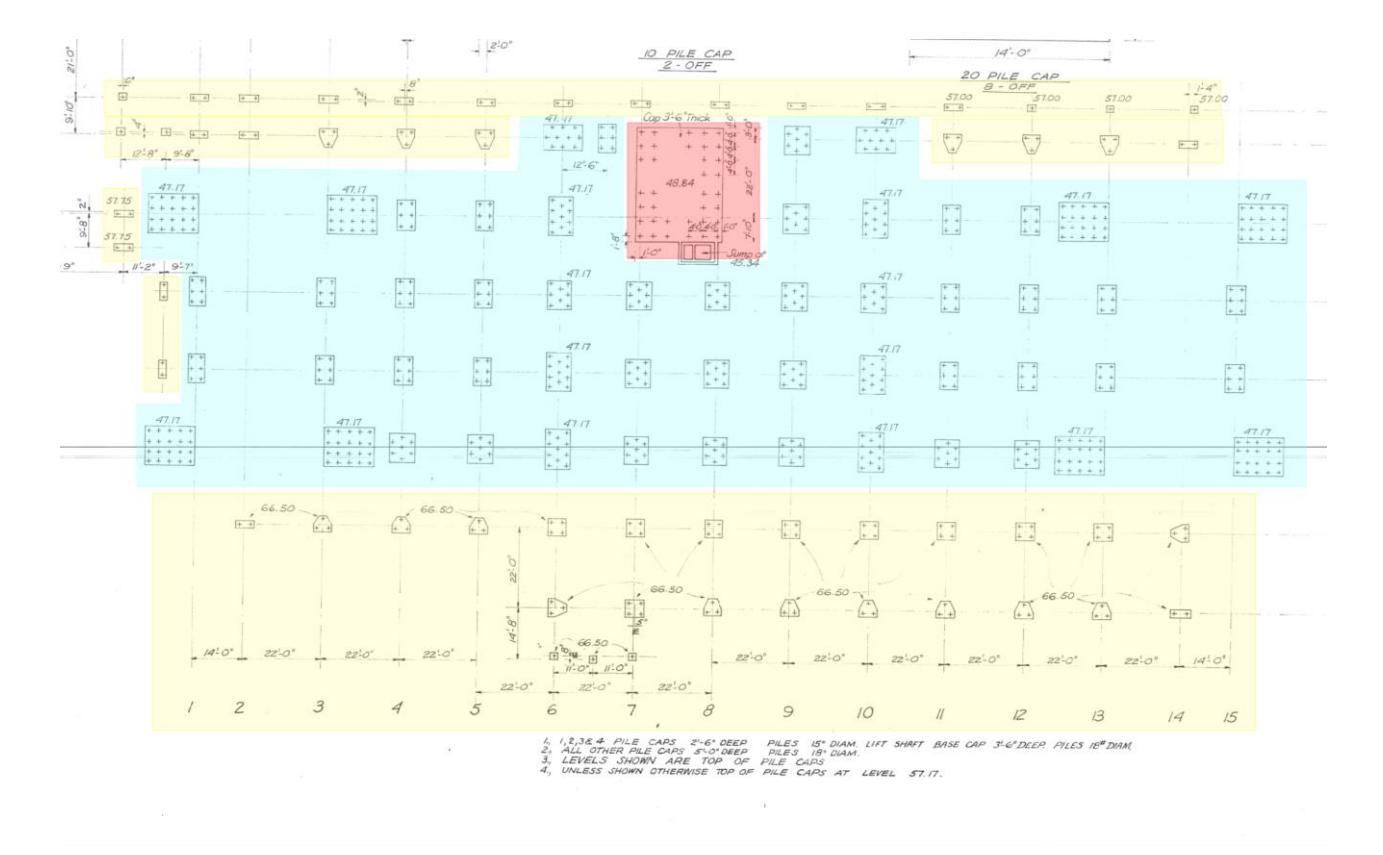
Figure 8: Different pile types by colour (Red P1, Blue P2 and Yellow P3)

The foundation system comprises of three pile types - P1, P2 and P3 – with 7.6m, 7m and 4.7m lengths, and 380mm, 457mm and 457mm diameter, respectively. Pile stiffnesses and capacities (different piles' group are shown in Figure 8) were considered based on a desktop geotechnical study by Aurecon. From the geotechnical study, the piles were found to be slender (long with relatively small diameter) and provide low horizontal stiffness. This was further exacerbated as the piles were typically located in the liquifiable zone (3-6 meters below ground level). The soil and pile properties based on the available data are tabulated in Table 10.

The investigation and review of the available geotechnical information indicates that site consists of loose sand/silts, highly susceptible to liquefaction between the depths at 3.0m and 6.0m. The groundwater table is expected to be around 3.0m to 4.5m depths below the ground. The thickness of the liquefiable layers and depths to groundwater table were inferred from the available ground information and could vary across the site.

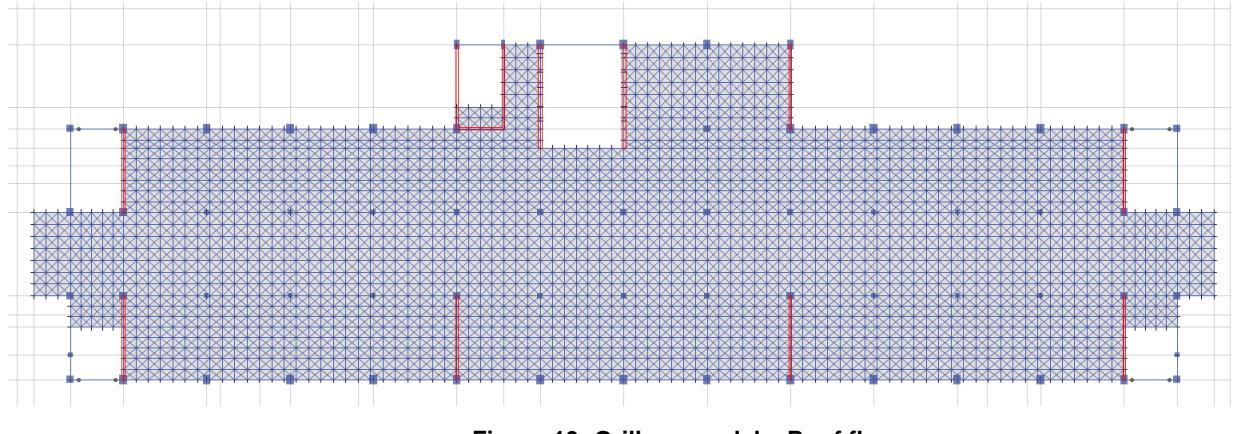
Figure 10: Grillage model – Roof floor

The diaphragm was assigned a minimal rating of 15%*NBS*(IL3) for the first, roof and ground floors due to lack of a reliable load path for transferring the lateral loads. This is mainly because of the considerable amount of transfer load that needs to be resisted by the diaphragm at those levels. The capacity of the diaphragm was limited by the performance of the tension elements.
